Westinghouse Electric Corporation

SUBJECT: Monthly Progress Report
Contract AF 33(600)-40280

Progress Report

Period of 2/15/62 to 3/15/62

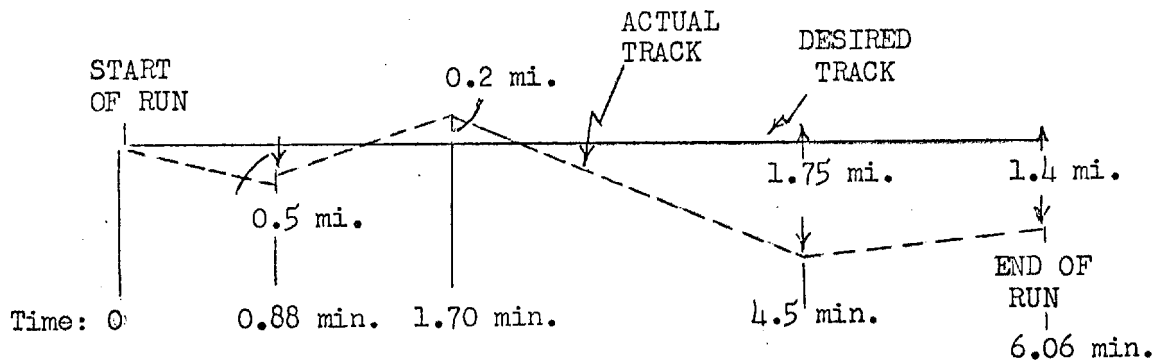
- a. Ground Speed: During the data run, momentary maximum and minimum ground speeds recorded were 845 and 818 knots. There was a gradual increase in the average ground speed from approximately 832 knots at the beginning of the data run to 838 knots at the end. Some oscillations of about 3 to 4 knots peak to peak occurred with random periods longer than six seconds. Higher frequency oscillations of one or two knots magnitude were observed by the pilot, but could not be seen on the recording. This is considered to be normal.
- b. Distance Off Track: The result of the distance off track recording is shown graphically in Figure 1. The figure is not to scale.

The track was allowed to deviate from the desired track, in the manner shown, so that the amount of course corrections would be minimum. The effect of being off the desired track is to change the area mapped slightly.
